COMMERCIAL WINDSTORM MITIGATION REPORT

The Placido Gardens Condominium Association, Inc.

As of 5/19/2020

4435 1st St NE, Units 101-312

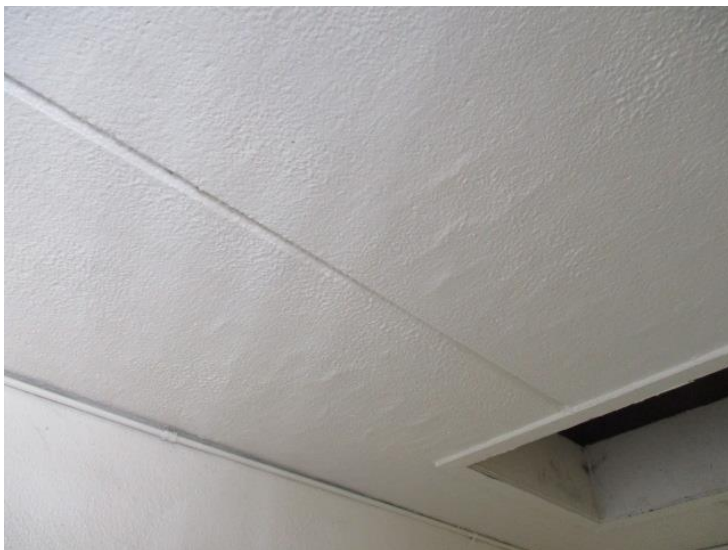
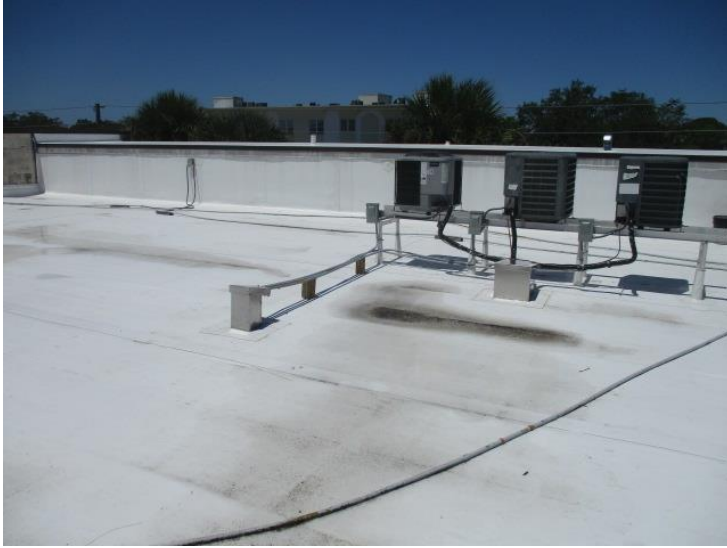
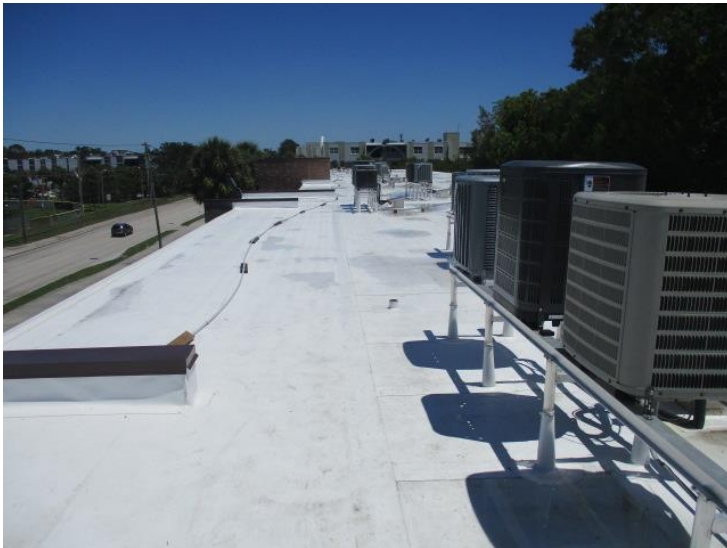
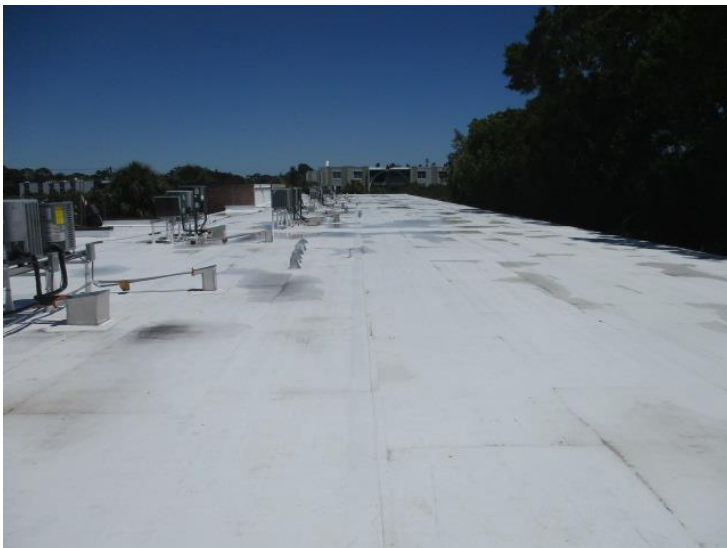
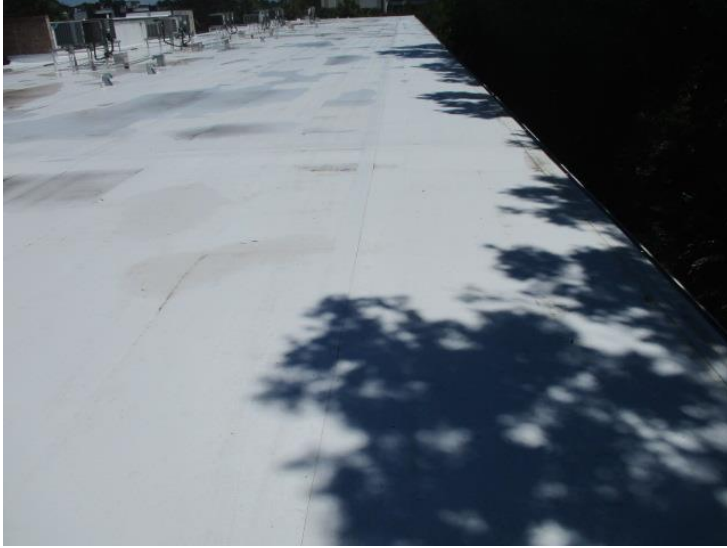
Roof Construction

3. **Roof Deck Attachment:** **Reinforced Concrete Roof Deck**
Comments: Inspection verified a roof structure composed of cast-in-place or pre-cast structural concrete designed to be self-supporting and integrally attached to the wall / support system.

4. **Roof to Wall Attachment:** **Structural**
Comments: Inspection verified a roof structure composed of cast-in-place or pre-cast structural concrete designed to be self-supporting and integrally attached to the wall / support system.

5. **Roof Geometry:** **Flat Roof**
Comments: Inspection verified flat roof shape, refer to attached photographs.
6. **SWR:** **No**
Comments: SWR does not apply to reinforced concrete roof decks.
